**WEEKLY REPORT**

Contract No./TDD	Project Title / Location	Date of Report	Report No.
EP-S8-13-01 0001/1502-04 & 1408-01	<b>EPA Region 8 Start IV Contract</b> <b>Red and Bonita Removal/Gold King Mine</b>	8/1/2015	3

## DAILY PRODUCTION & QUALITY CONTROL REPORT

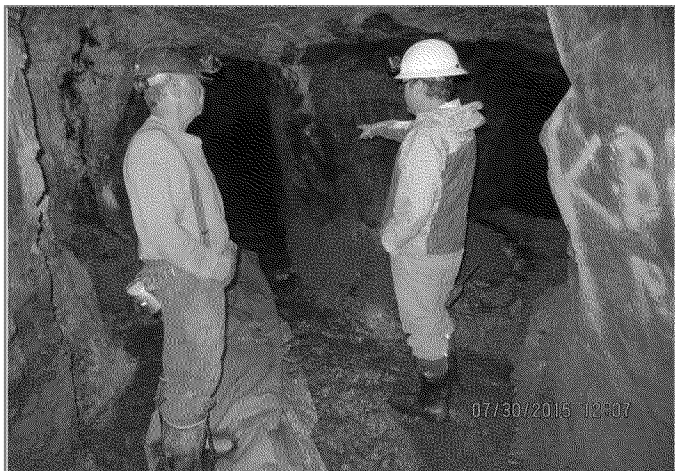
Photo 1

Back of the bulkhead location, minimal sludge is flowing from workings further back in the mine.

- MES finished initial mine solids clean out and as of 7/29, washing of the walls at the bulkhead location has been conducted.
  - MES installed the injection piping through the bulkhead section.
- NOTE: Untill the coffer dam is in place a minimal amout of solids is being transported through the work area from further back in the mine workings. Once the coffer dam is in place a final clean will be needed prior to inspection/acceptance of the cleaning.

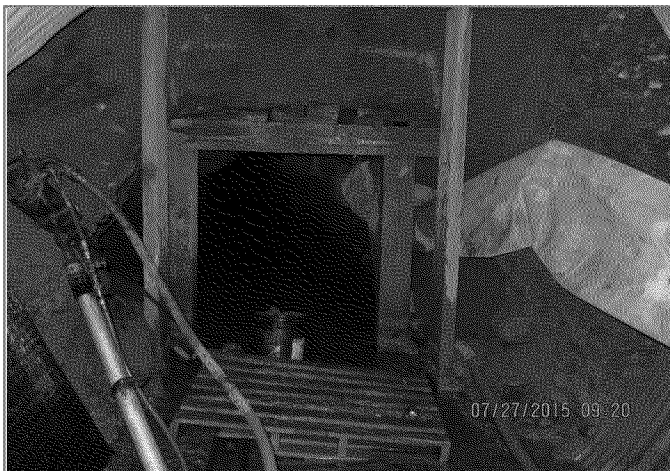
Photo 2

Low entry to the Red and Bonita, prior to safety signage.

- MES attempted to install reinforcement to raise the entrance cap/ceiling, conditions were not as anticipated so signage and illumination were installed to warn workers of the risk.
- Vehicles moving totes of caustic to the treatment area will be escorted from Gladstone storage area to treatment area to ensure safety.
- During non-work days ERRS loader will be parked across access to treatment area and caustic totes will be tarped.

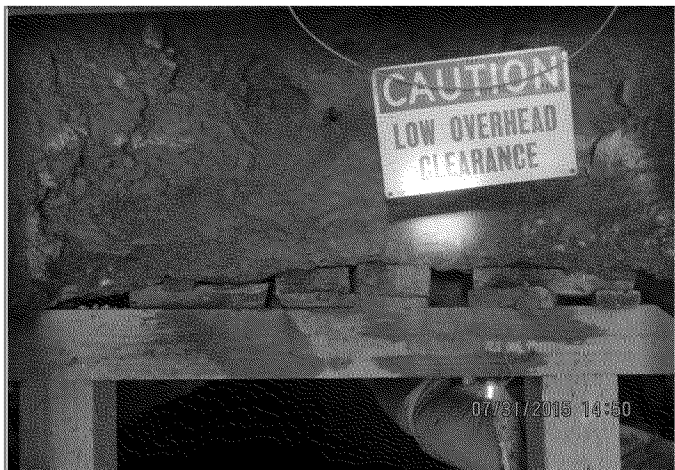
Photo 3

Low entry to the Red and Bonita, safety signage and flasher light on the daylight side.

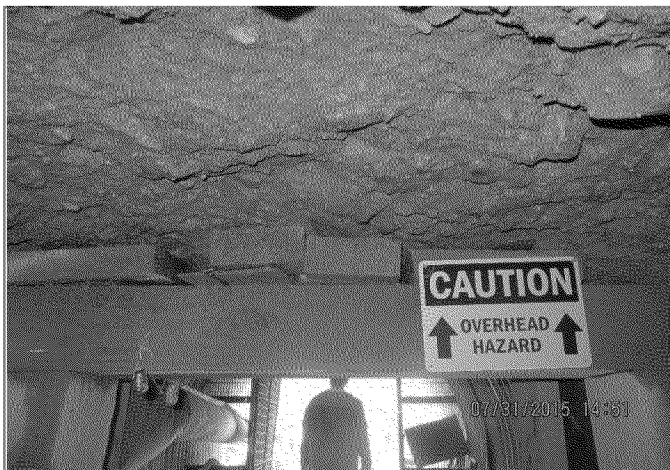
Photo 4

Low entry to the Red and Bonita, safety signage and flasher light on the in mine side.

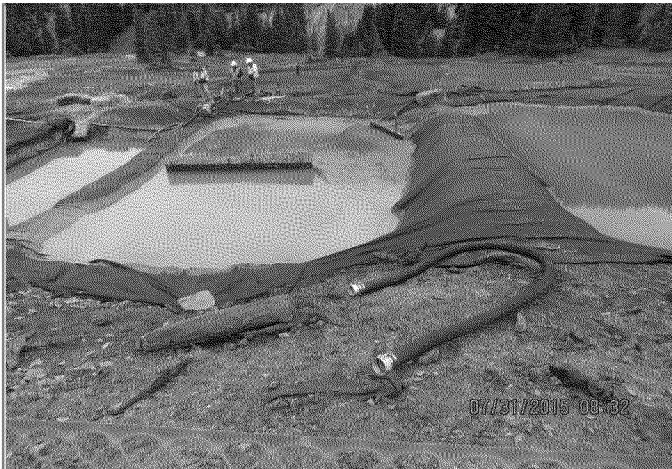
Photo 5

Treatment Pond 1 is full and treatment Pond 2 is roughly at 40% of capacity.

- Water Treatment ponds:
  - + Installed a baffle in pond 2 at the half way mark to increase settling time and redirect flow away from spillway into pond 3.
  - + Installed a baffle in pond 3 to redirect the water to the far corner of pond 3.
  - + Reinforcement posts were installed behind the hay bale wall to support the water load pressing against it.

- A Baffle was added in pond 2 to improve retention/settling time in pond 2.
- Approximately 545 gallons of caustic added; 1240 gallons of caustic remaining (note previous estimates did not include the 2 each 55 gallon drums of NaOH on-site.).
- Approximately 2 bags of Brennfloc used; 8 bags of Brennfloc remaining.
- Brennfloc addition rate is 1-2 turn/min of the hand seed broadcaster.

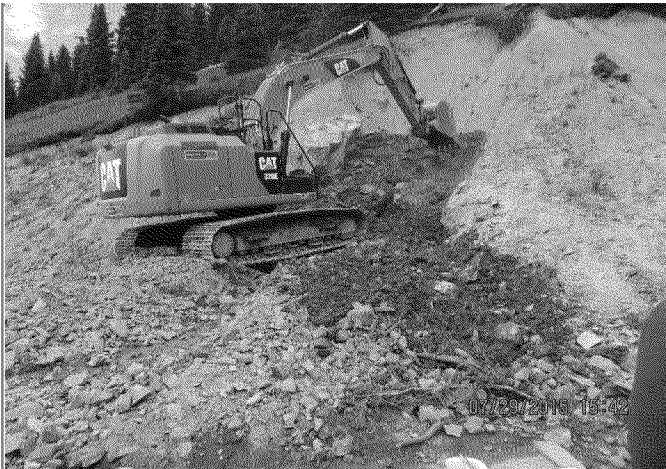
Photo 6

Excavating above collapsed adit at the Gold King mine.

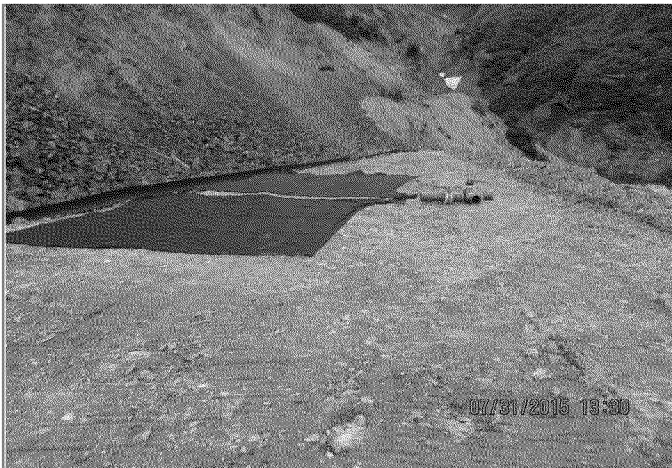
Photo 7

The Gold King start of filter bag manifold setup.

- Installed the 60 inch pipe as a sump basin, concreted the bottom to prevent seepage, and connected in the drainage pipe for outflow to the edge of the tailings dump.
- Began building the filter bag manifold if needed for treatment of solids from the mine discharge water.
